Magneto earth lead found broken on a single magneto assembly.

Taken from AAIU report No 2001-001

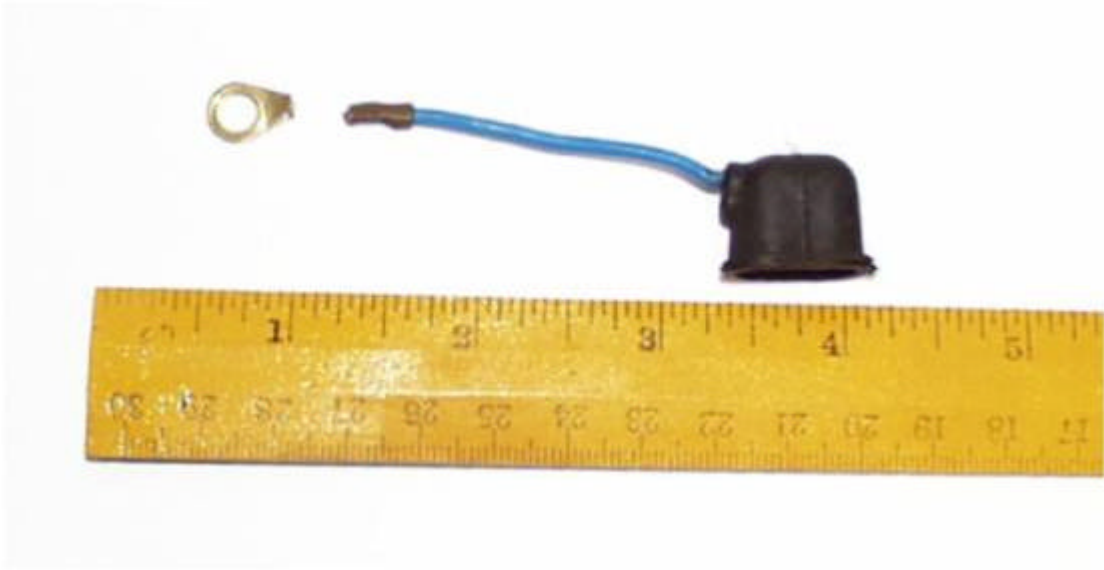
Fig 1

- Failure of the connection occurred over a period of time, through the propagation of a fatigue crack, to the point that the small remaining intact ligament failed through overload.
- The examination did not reveal any indication of a material or manufacturing defect associated with the fracture.
- There was no indication of arcing associated with the fracture. This would indicate that the separation of the connector was sudden and total.

The report said failure of the earth connection of the magneto coil would result in the sudden and total failure of the spark to one of the two engine cylinders. This in turn would lead to a power loss to the propeller exceeding 50%. Standard aircraft engines feature two totally separate magneto systems, each with its own spark plug in each cylinder. This is known as dual ignition. With such a system, the loss of one complete magneto system, or any component of that system, results in a relatively minor loss of power, thereby permitting a safe landing in the event of the failure of one ignition system. The single ignition system on the Rotax 447 engine has no such safety protection. Therefore such aircraft should be operated in a manner whereby an engine failure cannot be considered a remote possibility, but rather as a distinct probability. Consequently manoeuvres such as low runs, which would require normal engine power to be available for a safe recovery, should not be attempted in aircraft equipped with such engines. Such aircraft should be flown in manner that, following an engine failure at any time, the flight can be safely completed using a glide (powerless) landing.

The failed magneto lead showing the separated tab to the left of picture
